## Enhanced Preliminary Assessment Report:

Addison Army Housing Units  
Addison, Illinois

November 1989

Environmental Research Division  
Argonne National Laboratory  
Argonne, Illinois 60439

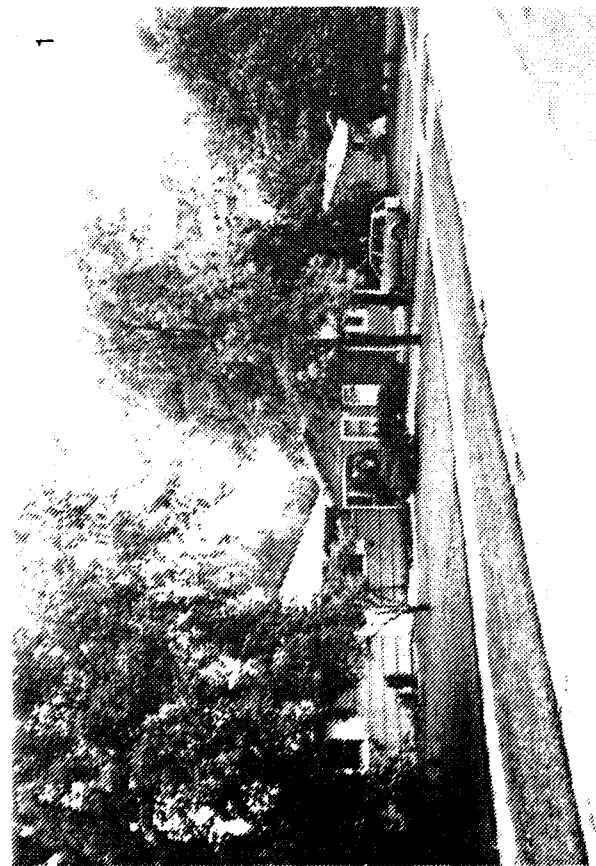
1

1. A view showing three of the four housing units on one row; there are three such rows of houses at this site.
2. Front view of one of the housing units, with parking area, and with storage shed at the rear.
3. Close-up view of another housing unit; front and side entrances to the house, and the down spout connected to the rain gutter, are seen.
4. The rear area between two rows of houses; storage sheds are in this area.
5. A playground for children; in the background, beyond the fence, are private residences.
6. Hot water heater and associated piping are shown here; insulation materials are not used around the heater and the pipes.
7. The furnace and air ducts shown here again evidence the absence of insulation materials.
8. Utility pole with a transformer mounted near the top; transformers at this site are owned and maintained by the U.S. government.
